# **INDOOR AIR QUALITY ASSESSMENT**

**Plymouth South Middle School  
488 Long Pond Road  
Plymouth, Massachusetts**

Prepared by:  
Massachusetts Department of Public Health  
Bureau of Environmental Health Assessment  
Emergency Response/Indoor Air Quality Program  
December 2003

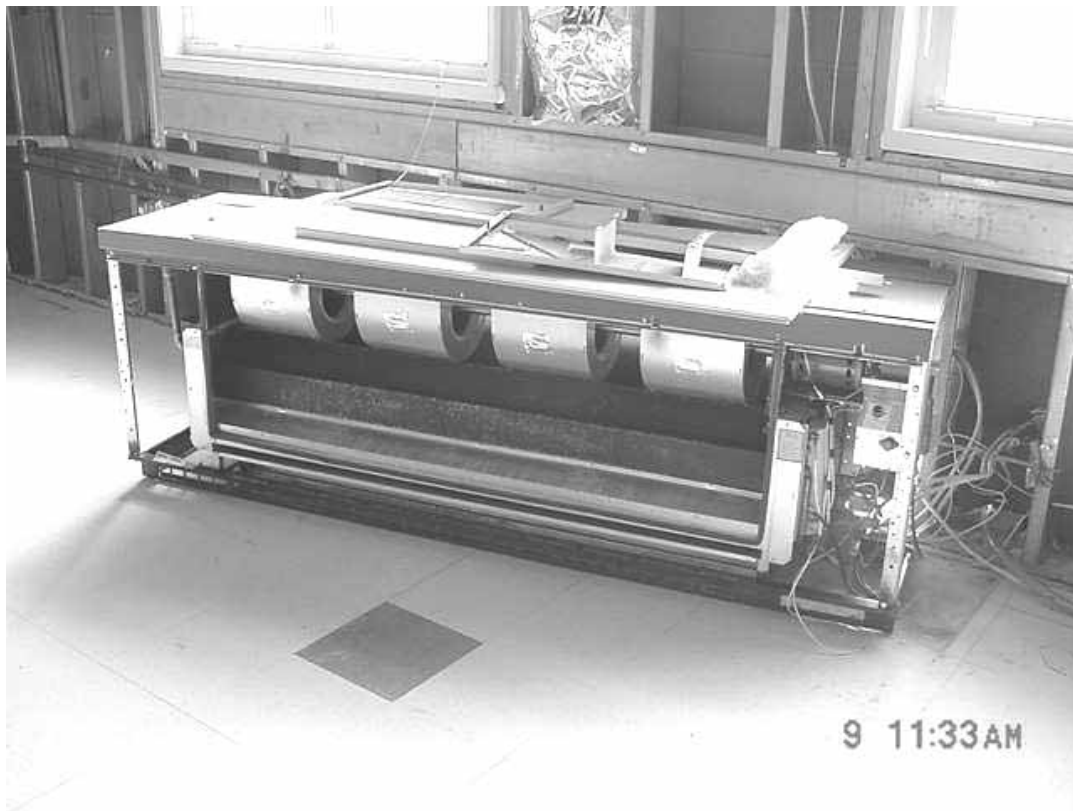
**Picture 1**

Fresh air in classrooms is supplied by a unit ventilator (univent) system (Picture 1). Univents draw air from outdoors through a fresh air intake located on the exterior

walls of the building and return air through an air intake located at the base of each unit ([Figure 1](#)). Fresh and return air are mixed, filtered, heated or cooled and provided to classrooms through a fresh air diffuser located in the top of the unit. Adjustable louvers control the ratio of outside to recirculated air. All univents in the classroom wing were disconnected to aid building repairs to prevent water penetration (Picture 1/Appendix A). The only means to introduce fresh air into classrooms at the time of the assessment was opening windows.

**Disconnected Univent in Classroom**

3. Examine each univent for function. Survey classrooms for univent function to ascertain if an adequate air supply exists for each room. Operate univents while classrooms are occupied. To increase airflow, set univent controls to “high”.

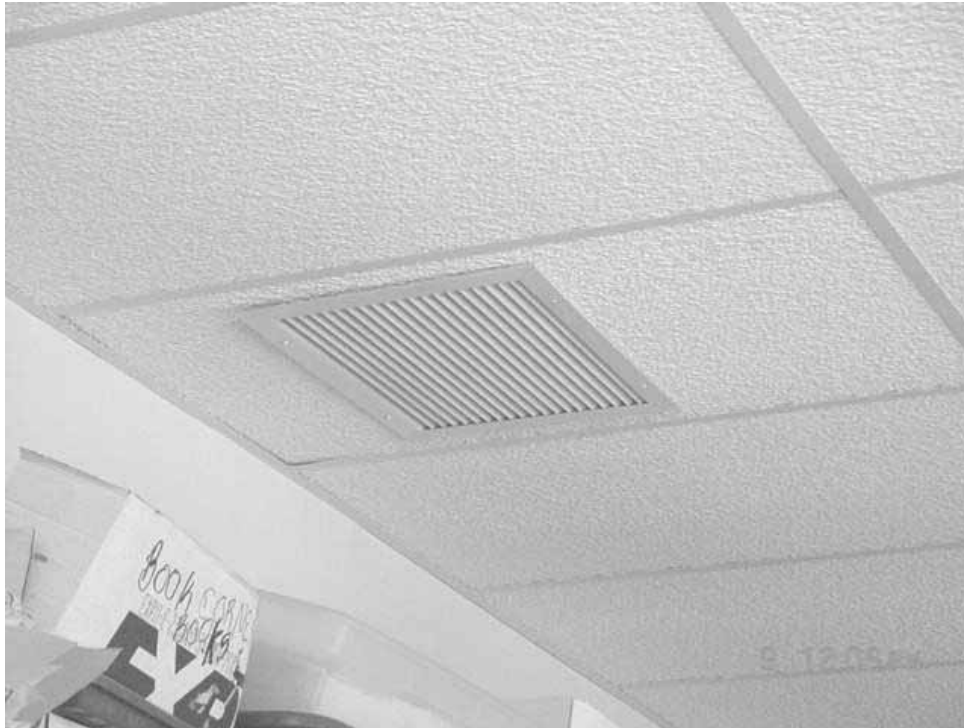
**Picture 2**

The mechanical exhaust ventilation system consists of wall-mounted exhaust vents connected to exhaust fans on the roof (Picture 2). This system was operating during the assessment facilitating the draw of fresh air into classrooms. The operation of the exhaust system depressurizes the classroom, which draws, outside air through open windows. BEHA staff recommended that classroom occupants open windows (to be used in conjunction with mechanical exhaust vents) to create cross-ventilation until univents were installed.

**Classroom Return Vent**

1. Continue with plans to repair flashing around univents and make repairs to the building envelope to prevent further water penetration.
2. Once univents are installed the BEHA recommends that both supply and exhaust ventilation operate continuously during periods of school occupancy independent of classroom thermostat control. Consider having ventilation systems re-balanced by an HVAC engineering firm.

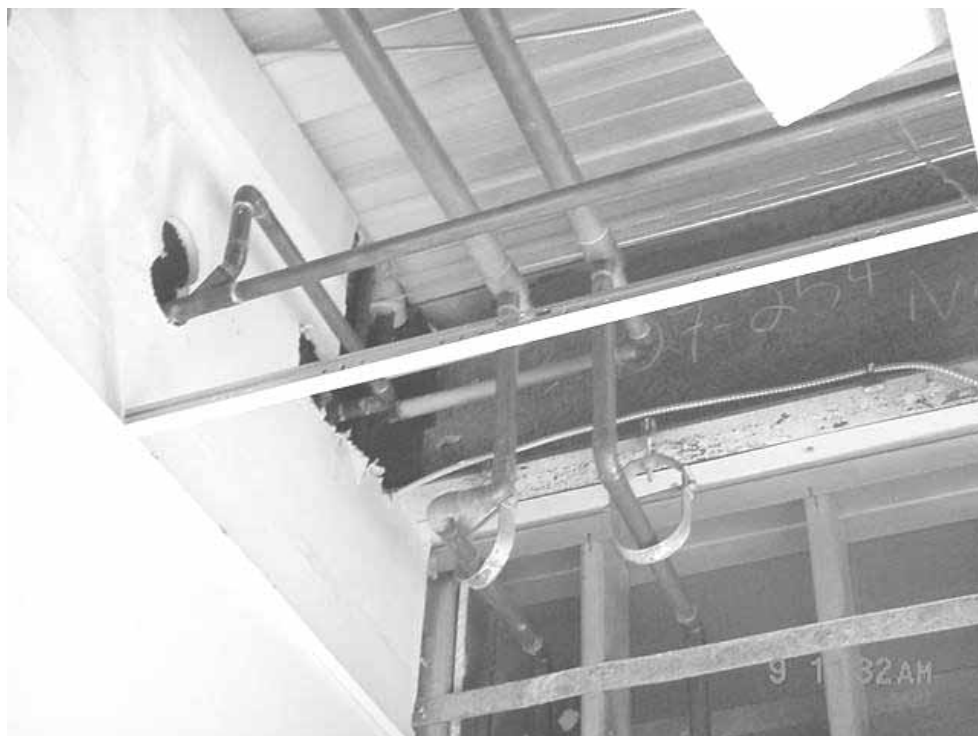
**Picture 3**

Materials in the building that were reportedly colonized with mold included both fixed building components (e.g., gypsum wallboard, pipe insulation) and movable materials (e.g., books, desks and tables). At the time of the assessment all mold-contaminated materials were removed (Pictures 3 & 4). Microbial remediation and cleaning activities were conducted by LVI Environmental Services, Inc. under the direction of Covino Environmental Associates, Inc who submitted a Microbial Remediation Work Plan (Covino, 2003) to the PSD. The first floor was unoccupied during the assessment due to renovation work being conducted to install new building components; work was completed on the second and third floors, which were occupied during the assessment.

**Pipe Insulation and Ceiling Tiles Removed in First Floor Classroom**

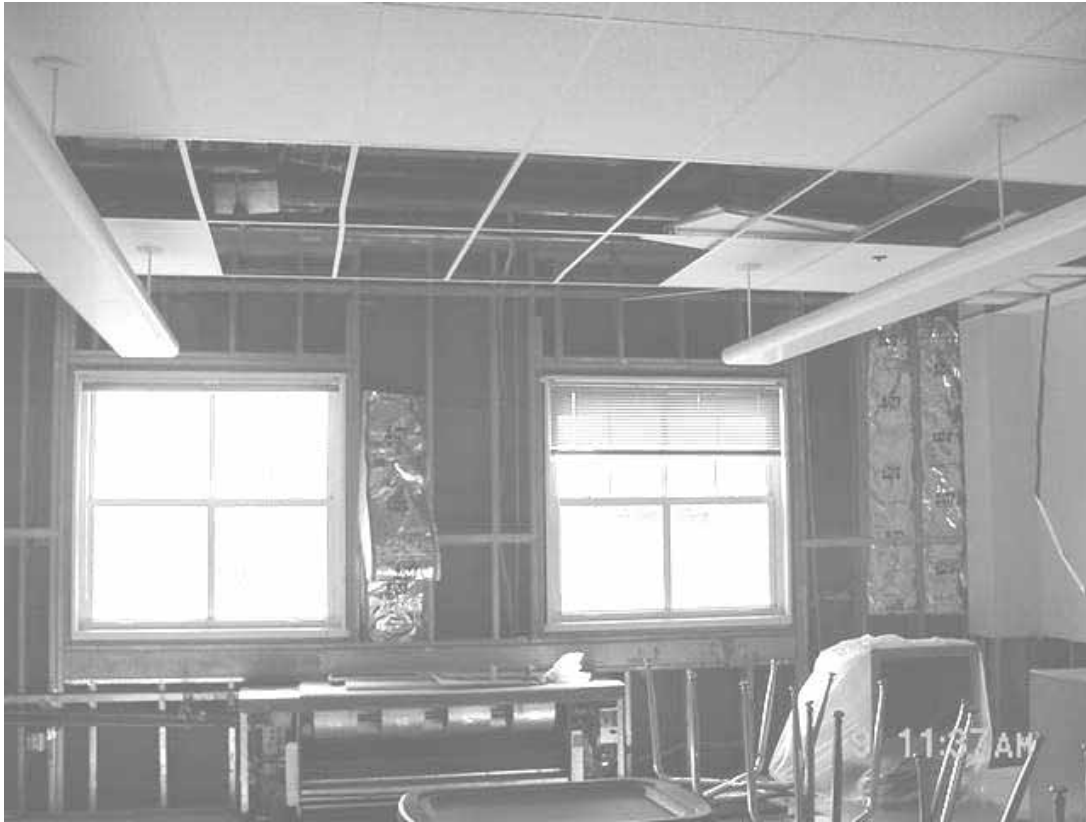
**Picture 4**

**Wall Materials, Ceiling Tiles and Pipe Insulation Removed in First Floor Classroom**

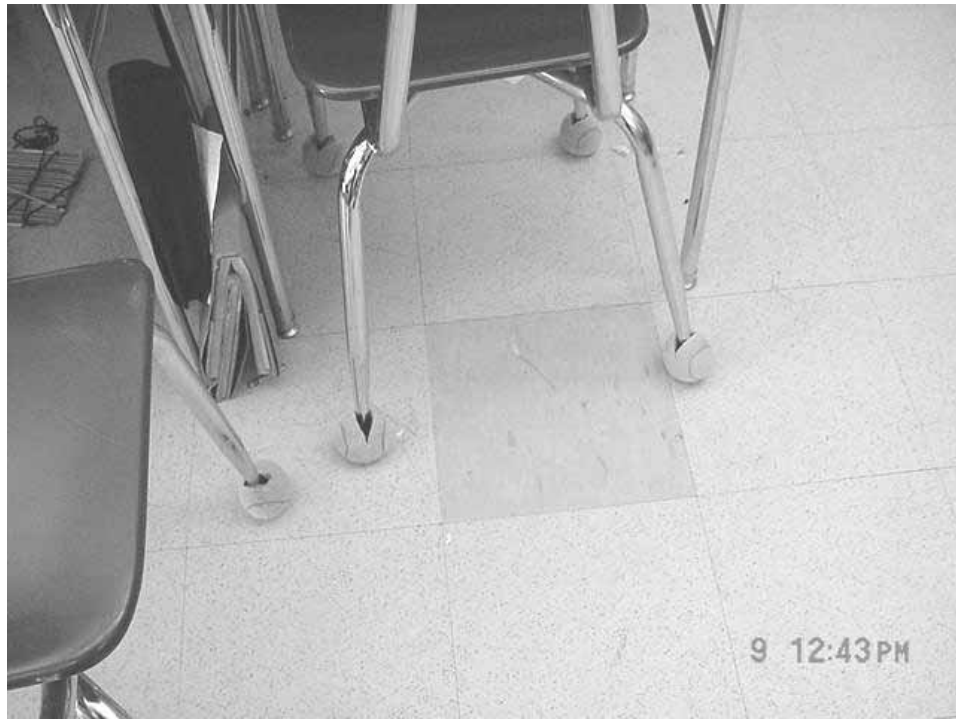
**Picture 5**

Finally, in an effort to reduce noise from sliding chairs, tennis balls had been sliced open and placed on chair legs (Picture 5). Tennis balls are made of a number of materials that are a source of respiratory irritants. Constant wearing of tennis balls can produce fibers and lead to off gassing of VOCs. Tennis balls are made with a natural rubber latex bladder, which becomes abraded when used as a chair leg pad. Use of tennis balls in this manner may introduce latex dust into the school environment. Some individuals are highly allergic to latex (e.g., spina bifida patients) (SBAA, 2001). It is recommended that the use of materials containing latex be limited in buildings to reduce the likelihood of symptoms in sensitive individuals (NIOSH, 1997). A question and answer sheet concerning latex allergy is attached as [Appendix C](#) (NIOSH, 1998).

**Tennis Balls on Chair Legs in Classroom**

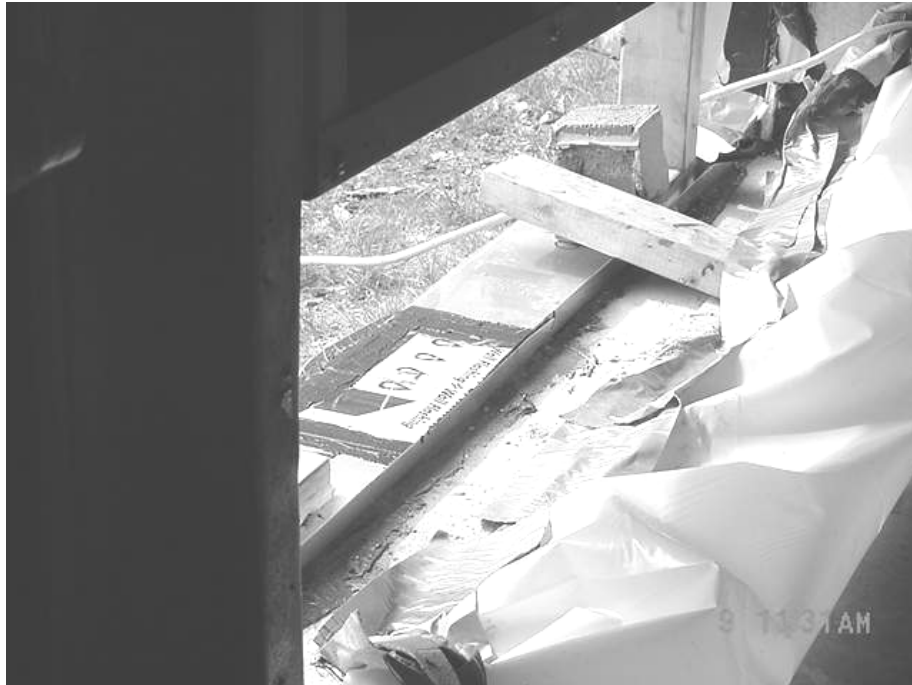
**Picture A1**

drainage problems with the curtain wall/drainage plain as well as end dam flashing around univents duct sleeves. At the time of this assessment masons were in the process of finalizing repairs to univent end dam flashing and drainage plain issues (Pictures A1 & A2).

**Interior View of Repairs to Univent End Dam Flashing/Drainage Plain**

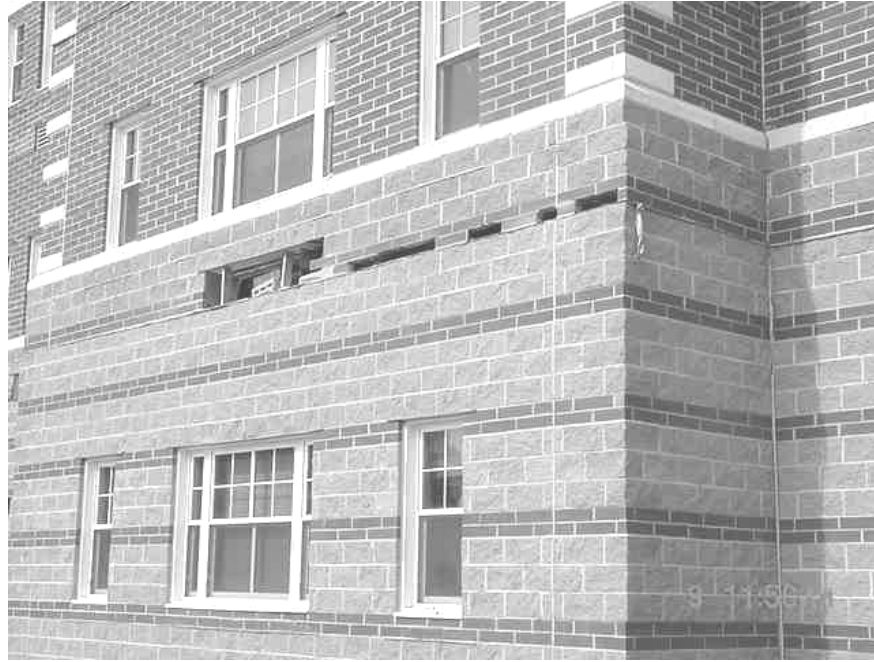
**Picture A2**

**Masonry Removed to Conduct Repairs to Univent End Dam Flashing/Drainage Plain**
